**National Highway
Traffic Safety
Administration**

Case Vehicle (A): 1999 Ford
Type: F-150, Extended cab 4x2 pickup
Driver: 33-year-old male
CDC: 12-FDAA-8

This is a fatal crash. The driver of case vehicle (A) died as a result of injuries sustained in this crash.

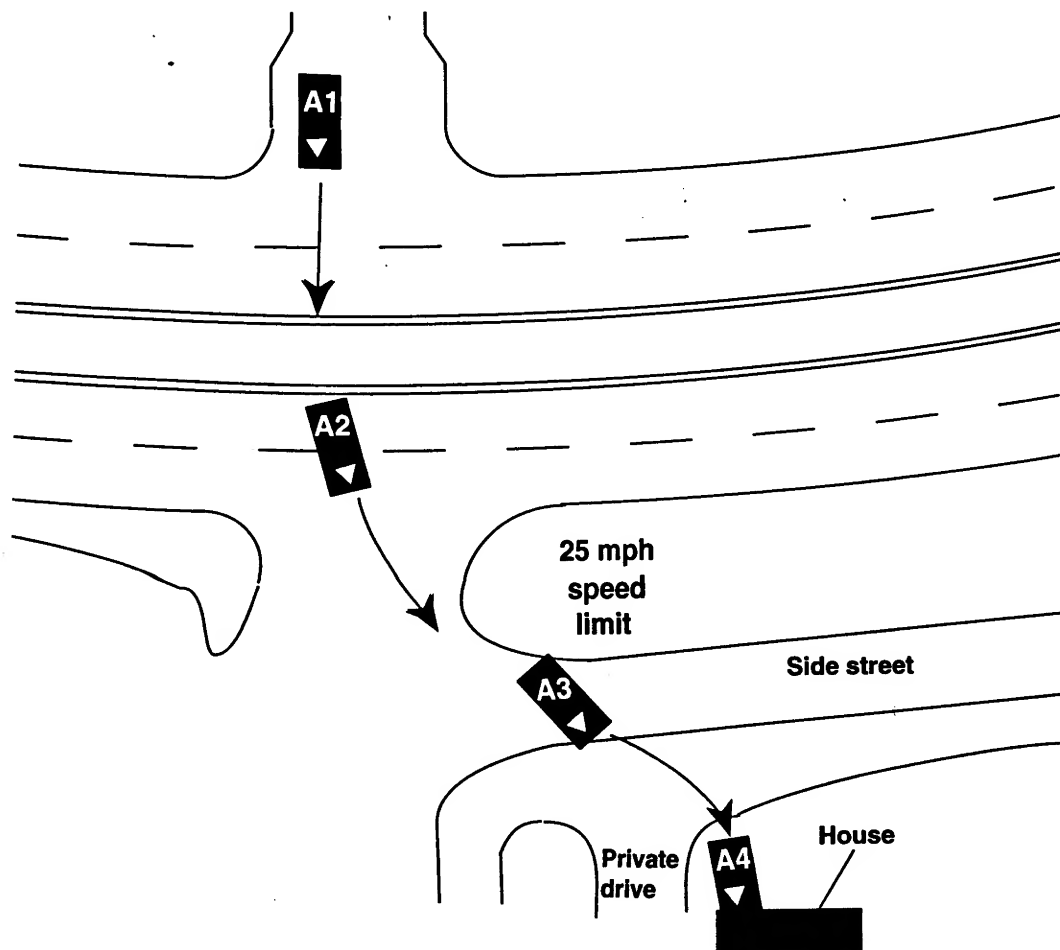
ACCIDENT DESCRIPTION: Case vehicle (A) had been traveling in the southbound lane of a 2-lane roadway, and had stopped at a 4-leg intersection. Case vehicle (A) began to cross the intersecting 5-lane roadway, and for an unknown reason veered left, exited the intersection, and crossed into the northbound traffic lane. Case vehicle (A) then departed the east side of the road, crossed a side street, entered a private drive, and struck a 2-story house with its front end. As the vehicle penetrated the wall of the house, the windshield header struck the 2-story floor joists, resulting in an inverted step pattern of damage to case vehicle (A). The blood and urine of the driver tested positive for THC.

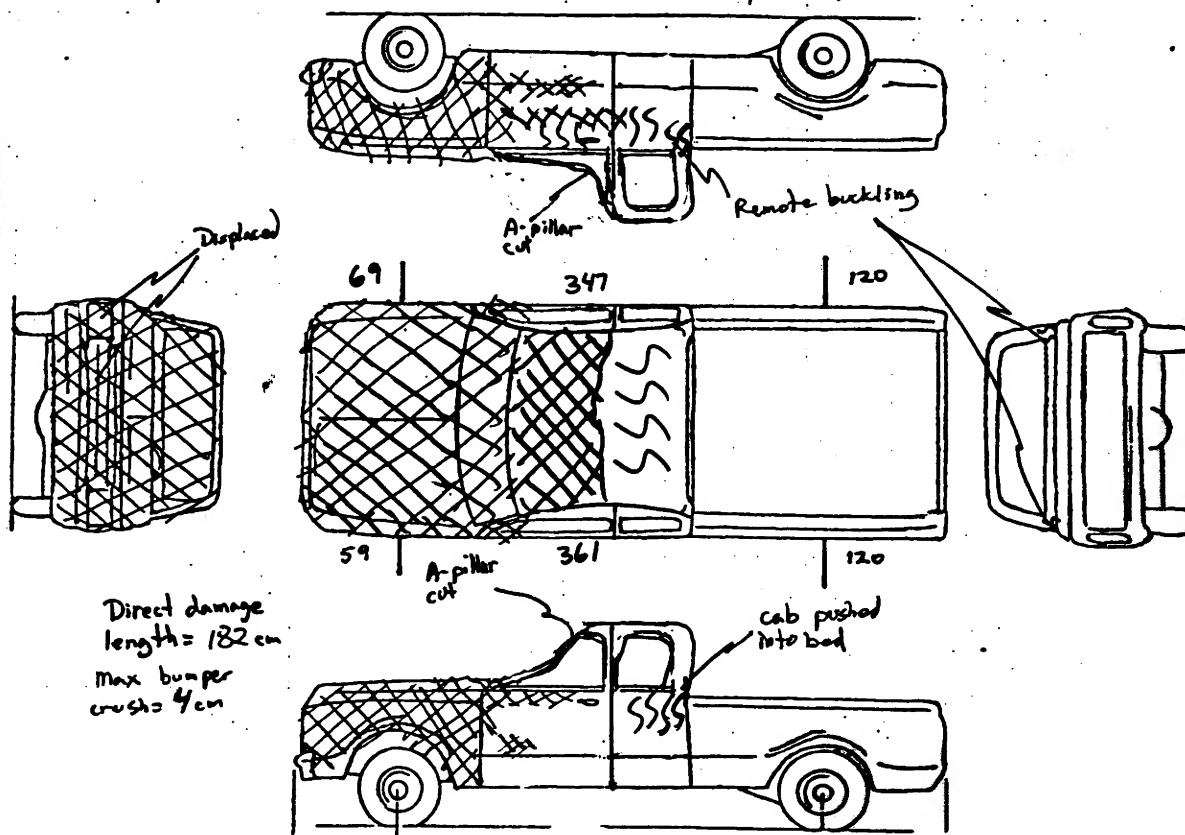
VEHICLE DAMAGE

(Slide 6) Damage to case vehicle (A) was severe. The most significant crush occurred to the greenhouse, at the level of the windshield-header. The direct-damage length was 182 cm and began at the left-front bumper corner. The maximum crush at the bumper level was 4 cm and occurred 36 cm inboard from the right-front bumper corner. The left wheelbase was increased 9 cm, and the right wheelbase was decreased by 5 cm.

Wheelbase	<u>352</u> cm	Front Overhang	<u>094</u> cm
Curb Weight	<u>1916</u> kg	Rear Overhang	<u>123</u> cm
Average Track Width	<u>172</u> cm	Undeformed End Width (UEW)	<u>185</u> cm
Overall Length	<u>569</u> cm	Engine Displacement	<u>4.6</u> L
Overall Width (OAW)	<u>199</u> cm	Engine: # of Cylinders	<u>08</u>

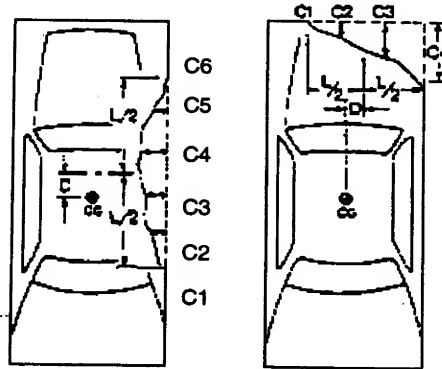
Specific Impact No.	Location of Direct Damage	Location of Field L
1	Begins @ Front bumper corner	B.C. to B.C.

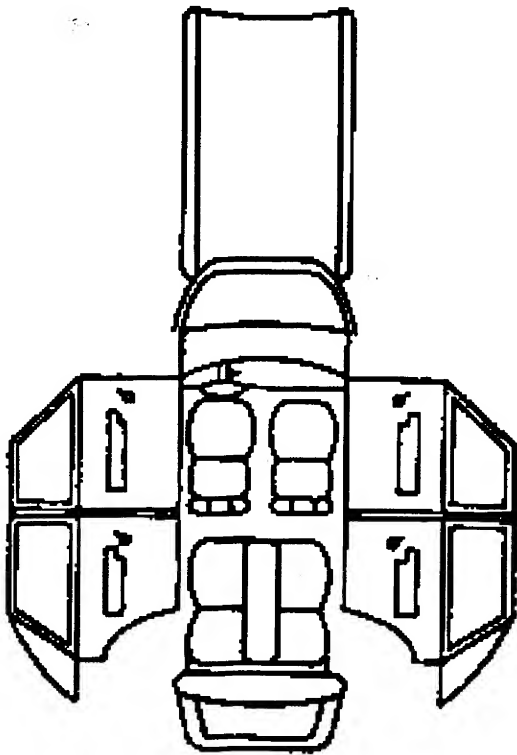
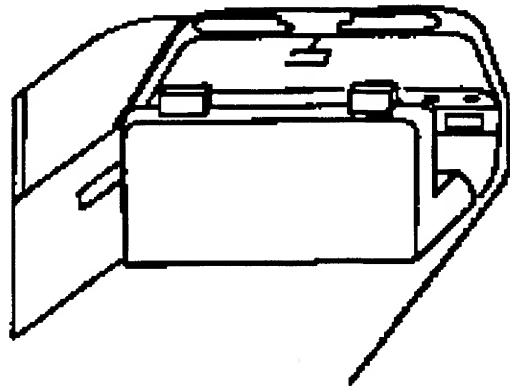
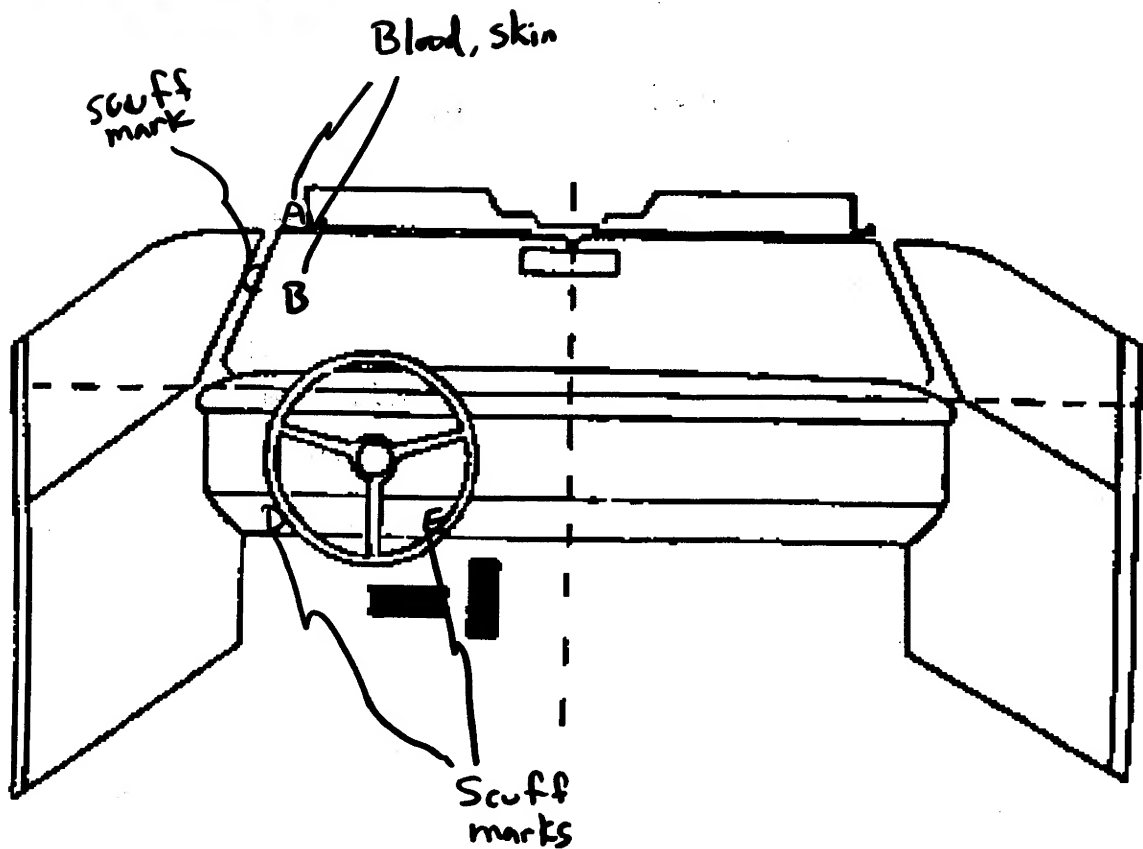
VEHICLE OCCUPANT CONTACT DIAGRAM

Contact	Interior Component Contacted	Occupant No. if Known	Body Region if Known	Supporting Physical Evidence	Confidence Level of Contact Point
A	Header	1	head	Blood, skin	1
B	Windshield	1	face	" "	1
C	A-pillar	1	shoulder	Scuff mark	2
D	Knee bolster	1	knee	" "	1
E	Knee bolster	1	knee	" "	1
F					
G					
H					
I					
J

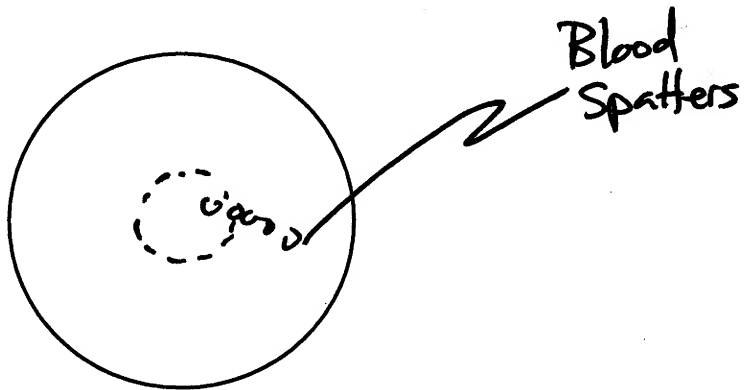
AIRBAG NUMBER ON DRIVER SIDE:

NOTE AND DESCRIBE ANY AIRBAG CONTACT OR
DAMAGE ON DIAGRAM BELOW:

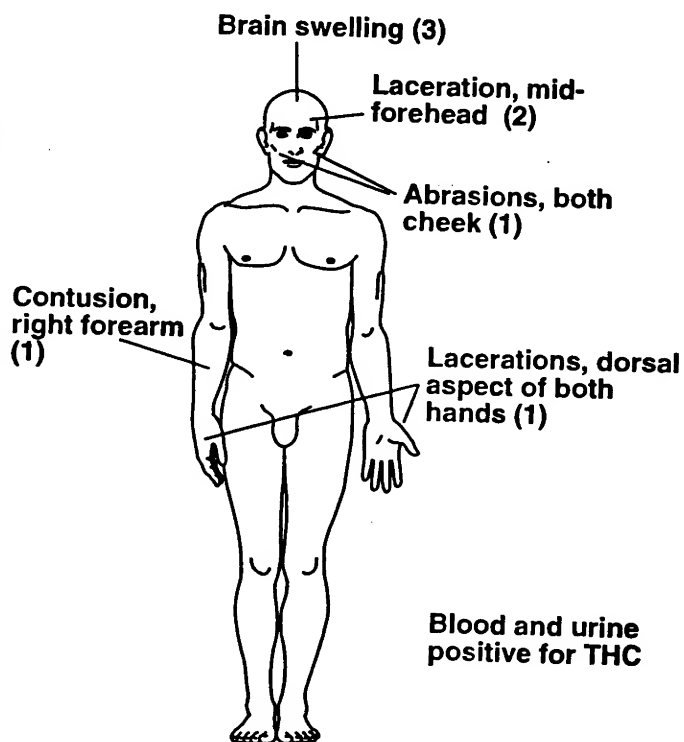
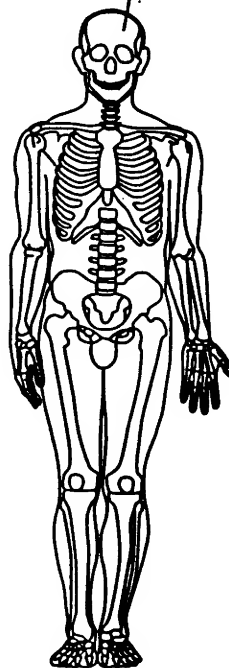
Fracture; depressed, involving frontal bones and cranial fossa with laceration to frontal and right temporal lobes of cerebrum (4)

Injury Description	A.I.S.	Injury Source		
		Definite	Probable	Possible
Fracture; depressed, involving the frontal bones and cranial fossa	4	Windshield header and left sunvisor post	Flying glass	Steering-wheel rim or airbag
Lacerations to the frontal and right temporal lobes of cerebrum	4	Windshield header and left sunvisor post		
Brain swelling	3	Windshield header and left sunvisor post		
Laceration, mid-forehead (>10 cm and into subcutaneous tissue)	2	Windshield header and left sunvisor post		
Abrasions, both cheeks	1	Windshield		
Contusion, right forearm	1			
Lacerations, dorsal aspect of both hands	1			
<u>Maximum A.I.S. Level</u>	<u>4</u>			
<u>Injury Severity Score</u>	<u>20</u>	<u>FATAL</u>
